GENERAL CONDITION SURVEY

BREAST LINE BARGE “B-9-A”

OWNED BY: STATE OF OREGON, PORT OF PORTLAND DIVISION OF NAVIGATION

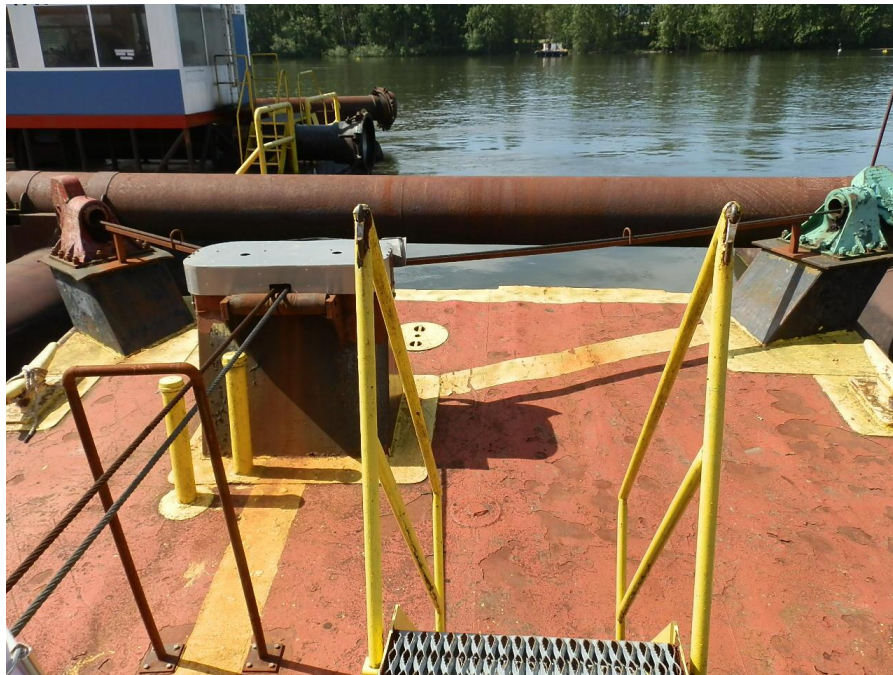
Bow deck

The bow deck contained scattered abrasions and was lightly work hardened from 0-1/2" with no one area worthy of specific mention.

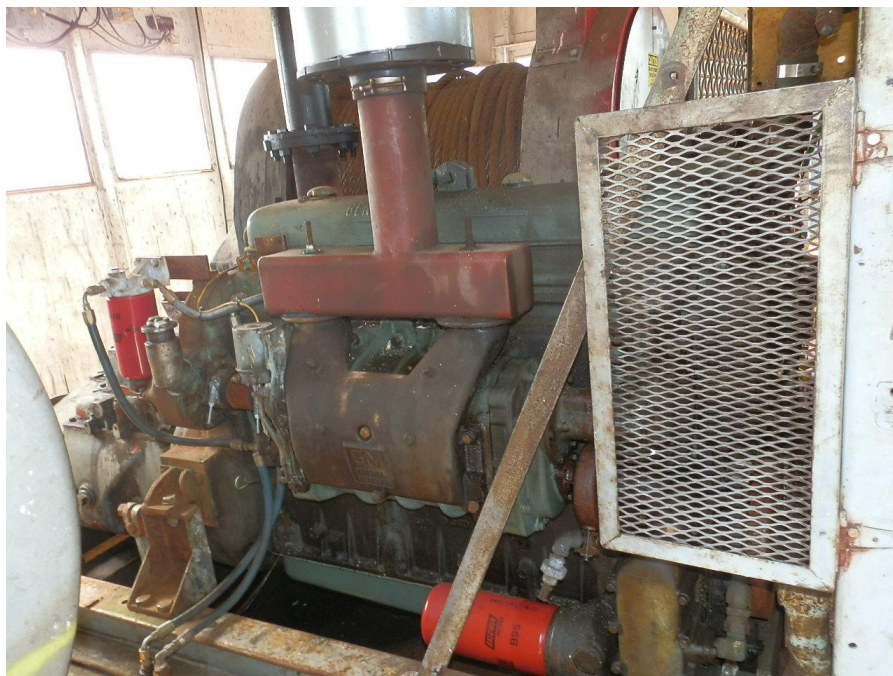
Winch motor in deckhouse

A Skagit, three-drum, waterfall deck winch spooled with 1" steel cable on all three drums was mounted in the center of the deckhouse. The winch was powered by a Detroit Diesel, 6-71, marine diesel engine through a Fuller transmission and chain drive. A 100 gallon diesel oil tank was mounted in the aft portion of the deckhouse.

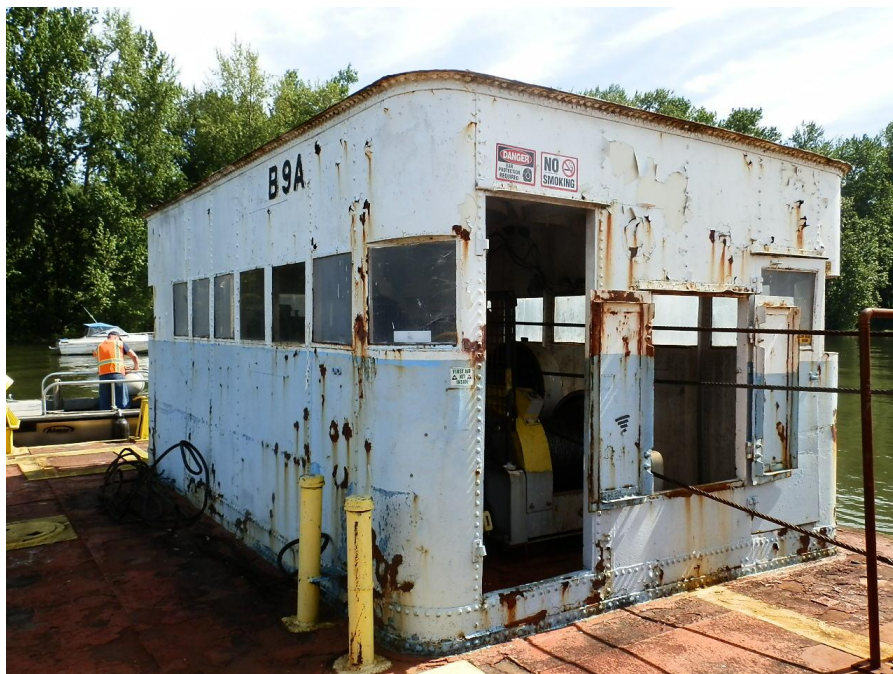
Deckhouse

An approximate 20' x 12' x 9', riveted steel deckhouse with a flat roof was constructed on the aft section of the barge deck. The deckhouse was painted white over its top half and blue on the lower half, with seven windows each in the port and starboard bulkheads. A hinged door in the forward bulkhead of the deckhouse provided access to the interior. The exposed steel overhead and bulkheads in the interior were painted white and the deck was painted with a red non-skid coating.

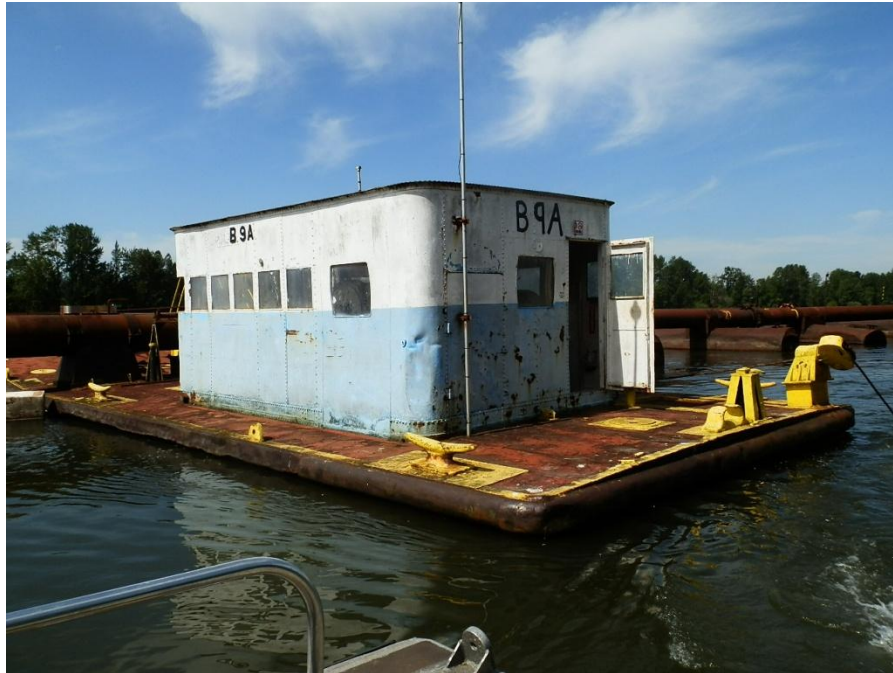
Port stern

The port stern corner plates contained scattered abrasions and indentations from 0-1" with no one area worthy of specific mention.

The port stern rake knuckle plates contained scattered abrasions and indentations from 0-1.5" with no one area worthy of specific mention.

The port stern side plates were difficult to sight below the half pipe rub rail, but where visible were noted to contain scattered abrasions and indentations from 0-1/2" with no one area worthy of specific mention.

The 12" half pipe rub rail on the port stern side plating contained scattered abrasions and indentations from 0-1/2" with no one area worthy of specific mention.
